Rossing Uranium

Fatality 3rd March 2005

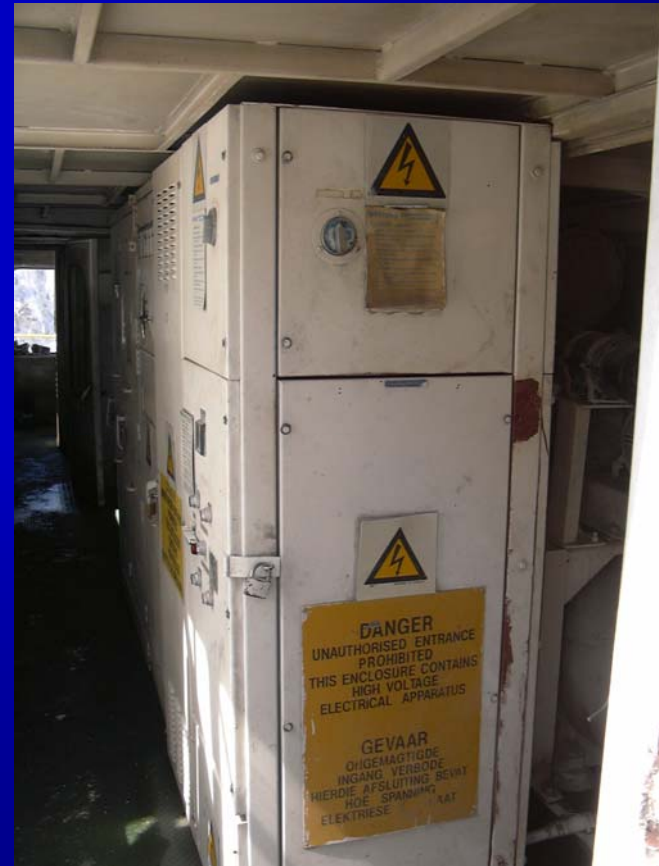
- Rössing Uranium Mine, Namibia.
- Mine site - Bench 20.
- Overburden Gardner Denver Drill # GD05 machine house electrical cabinet.

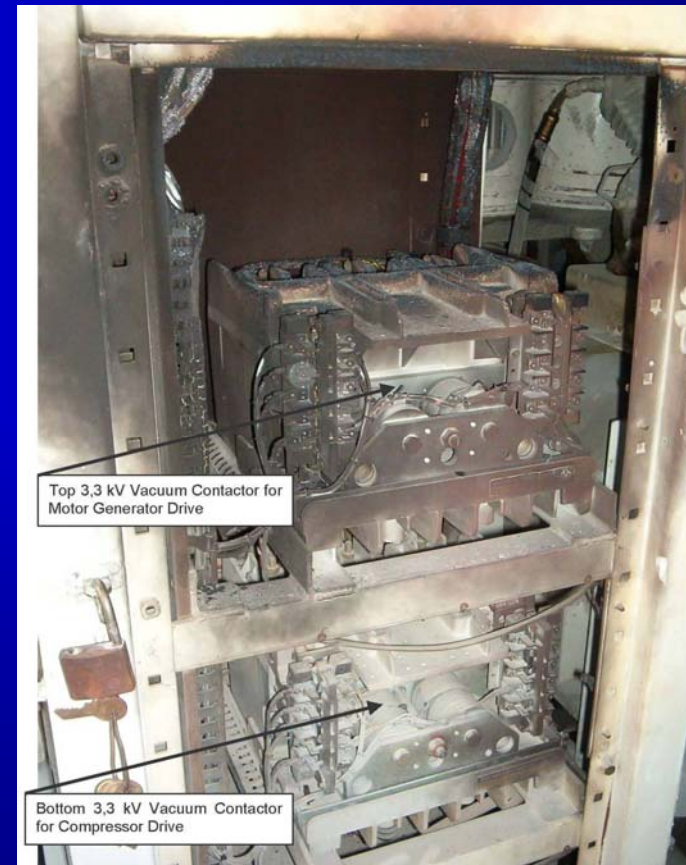
- During the fault finding process an attempt was made to measure incoming 3.3kV with a Multimeter rated at 1,000V AC. This initiated a short circuit between phase connections at the high voltage terminals located at the back of the vacuum contactor resulting in a flash.

- ◆ No specific machine training.
- ◆ No specific procedure exists to enter this high voltage cabinet.
- ◆ No evidence of job preparation
- ◆ No labels and/or barriers.
- ◆ Evaluation of appropriateness of the “on the job training” and standards to control this training.
- ◆ No training, no training objective associated with this task.
- ◆ Selection of worker criteria for shift work.
- ◆ Communication issues between staff and trades.

- ◆ Training to be machine and task specific.
- ◆ Evaluate the knowledge, skills and abilities of all pit electricians on machine electrics and test for competency.
- ◆ Identify all high voltage contactors and terminals and affix properly design labels and barriers.
- ◆ Ensure that shift tradesman have the right skill mix to perform the task.
- ◆ Review and compile risk register and specific safe work procedures.
- ◆ Enforce risk assessment.
- ◆ Develop and implement specific high voltage testing procedures.
